TEST REPORT

Report Number: 1376-09001

Sample Description: Acrylic/ plastic Free Standing Bathtubs with overflow and outlet drain holes

Scope of Testing: The purpose of the testing was to determine whether the samples submitted of the Acrylic plastic Bathtubs met the applicable requirements of ANSI Z124.1.2 – 2005 entitled, “American National Standard for Plastic Bathtub and Shower Units”.

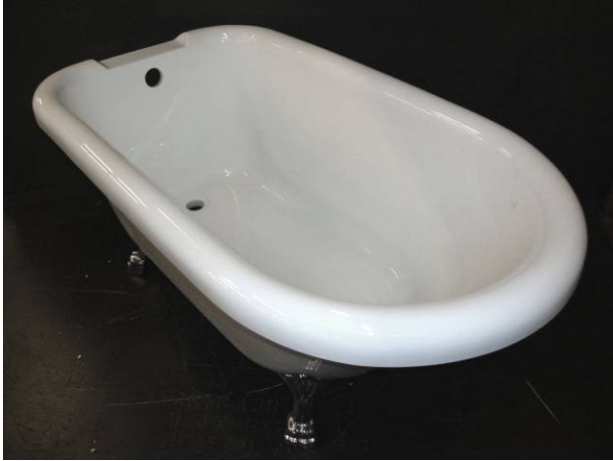
Models: HLFL53 – overall dimensions 53” x 30”x 19”
CLDBL73 – overall dimensions 73” x 32”x 22-7/8”
