# TEST REPORT

**Report Number:** 1376-09002

**Sample Description:** Acrylic/ plastic Free Standing Bathtubs with overflow and outlet drain holes

**Scope of Testing:** The purpose of the testing was to determine if the samples tested of the acrylic plastic bathtubs, models listed above met with the applicable requirements of CSA B45.0-02 and CSA B45.5-02.

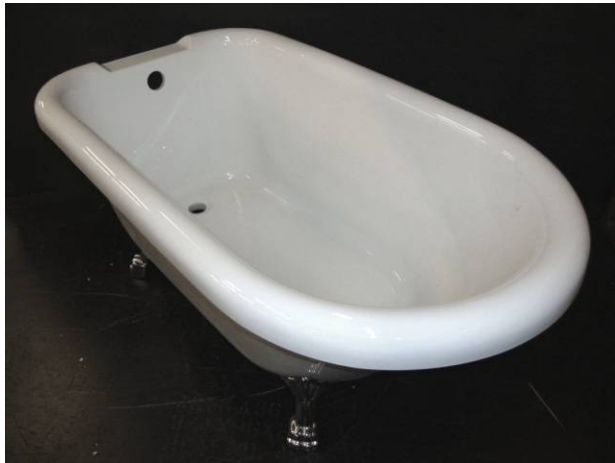
Models: HLFL53 – overall dimensions 53” x 30”x 19”  
CLDBL73 – overall dimensions 73” x 32”x 22-7/8”
